PRELIMINARY ASSESSMENT REPORT

**MCC RECYCLING, LLP
PASADENA, HARRIS COUNTY, TEXAS
TXR000079409**

**Prepared in cooperation with the
U.S. Environmental Protection Agency, Region 6**

April 2011

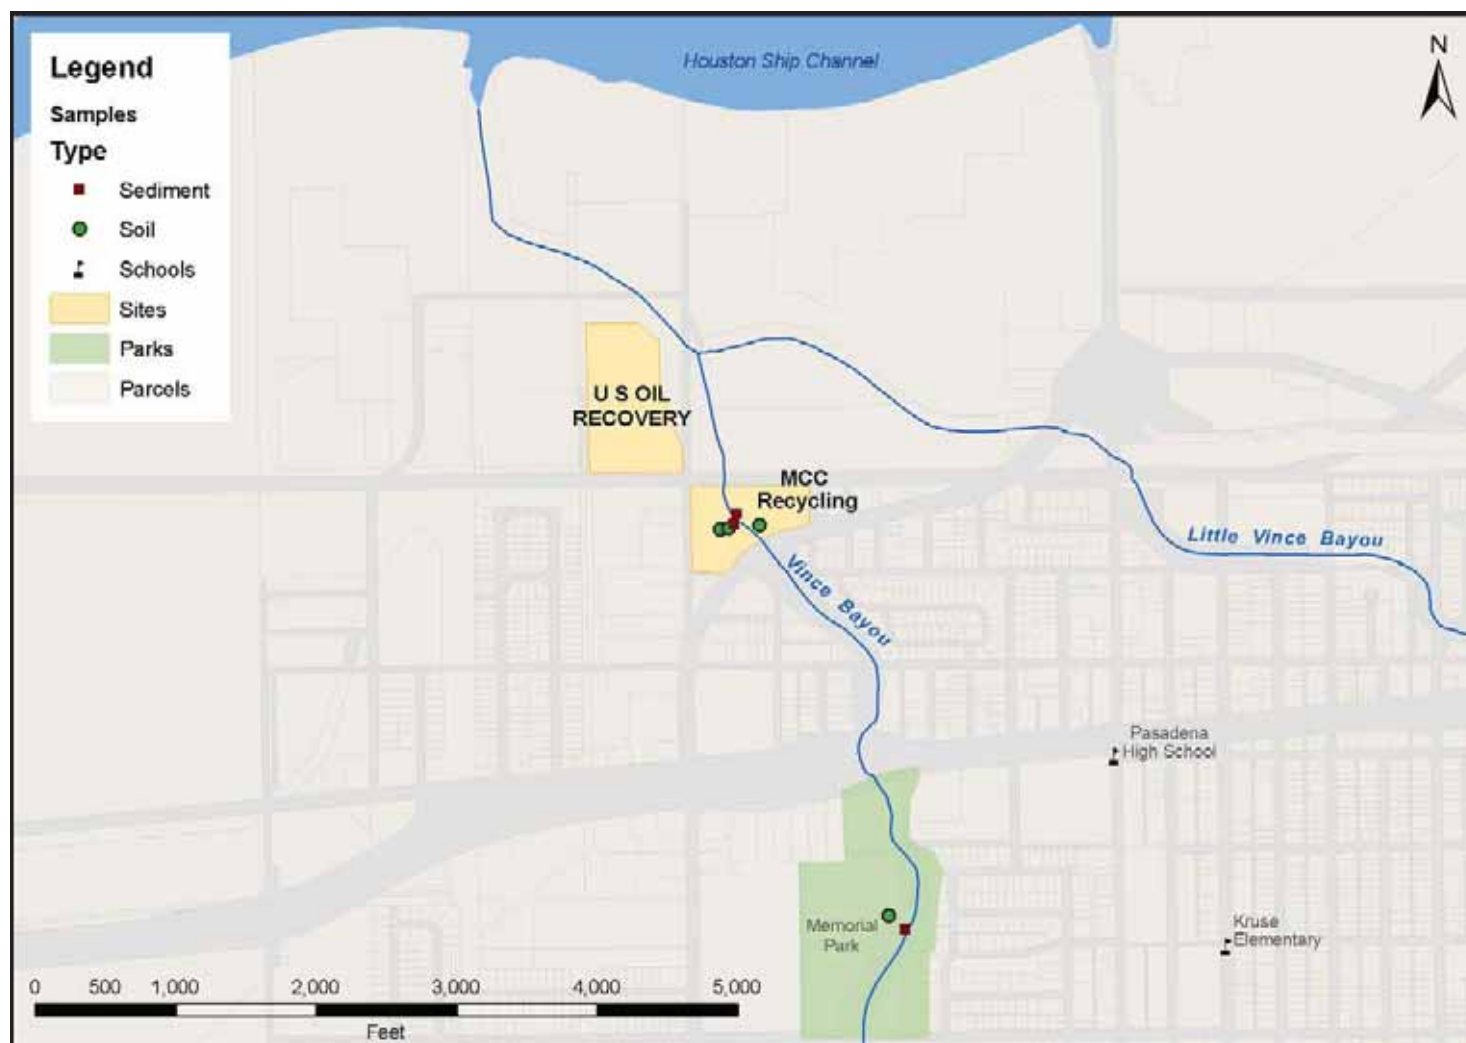
Figure 1

Site Map

MCC Recycling is a subsidiary of US Oil Recovery, LP. MCC Recycling is a treatment, storage, and disposal facility that receives wastes from another facility owned and operated by US Oil Recovery located at 400 N. Richey Street, Pasadena, Texas (see Figure 1). The US Oil Recovery facility processes and treats sludge and solids characteristically classified as hazardous waste, used oil, oily sludge and solids, municipal solid waste, and Class I and Class II Wastewater. Both facilities are located in an industrial area adjacent to the Houston Ship Channel in Pasadena, TX (see Figure 1).

Vince Bayou flows through the MCC Recycling facility and empties further downstream north of the facility directly into the Houston Ship Channel (see Figure 1). The bayou also extends south of the facility (i.e., upstream) into a residential area starting approximately $\frac{1}{4}$ – $\frac{1}{2}$ mile away from the facility. A public park (Memorial Park), 49 acres in size, sits along the southern stretch of the bayou (a green shaded polygon designating the outlined boundary of Memorial Park is shown in Figure 1). Fishing occurs along the bayou and near the facility. Residents also do recreational activities in or near the bayou at Memorial Park and could be potential receptors.

TCEQ contacted EPA Region VI and requested assistance with the May 2009 discharge from MCC Recycling. In response, EPA collected four surface soil samples: one from each side of Vince Bayou near the discharge area, one around the Roll Box on facility grounds, and one as a representative background sample further upstream in Memorial Park (see Figure 1). EPA also collected three sediment samples: one from each side of Vince Bayou near the discharge area, and one as background further upstream adjacent to Memorial Park (see Figure 1).
